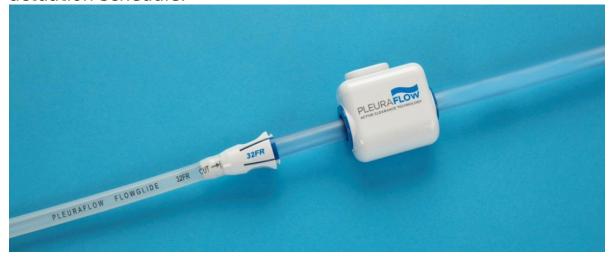
If decoupling occurs when the shuttle guide is in proximity of the parked position, the shuttle guide can continue to be used, even if not fully clicked into the parked position. Proceed with the actuation schedule.
