Additional Magnetic Strength

Guide Tube Path Not Straight

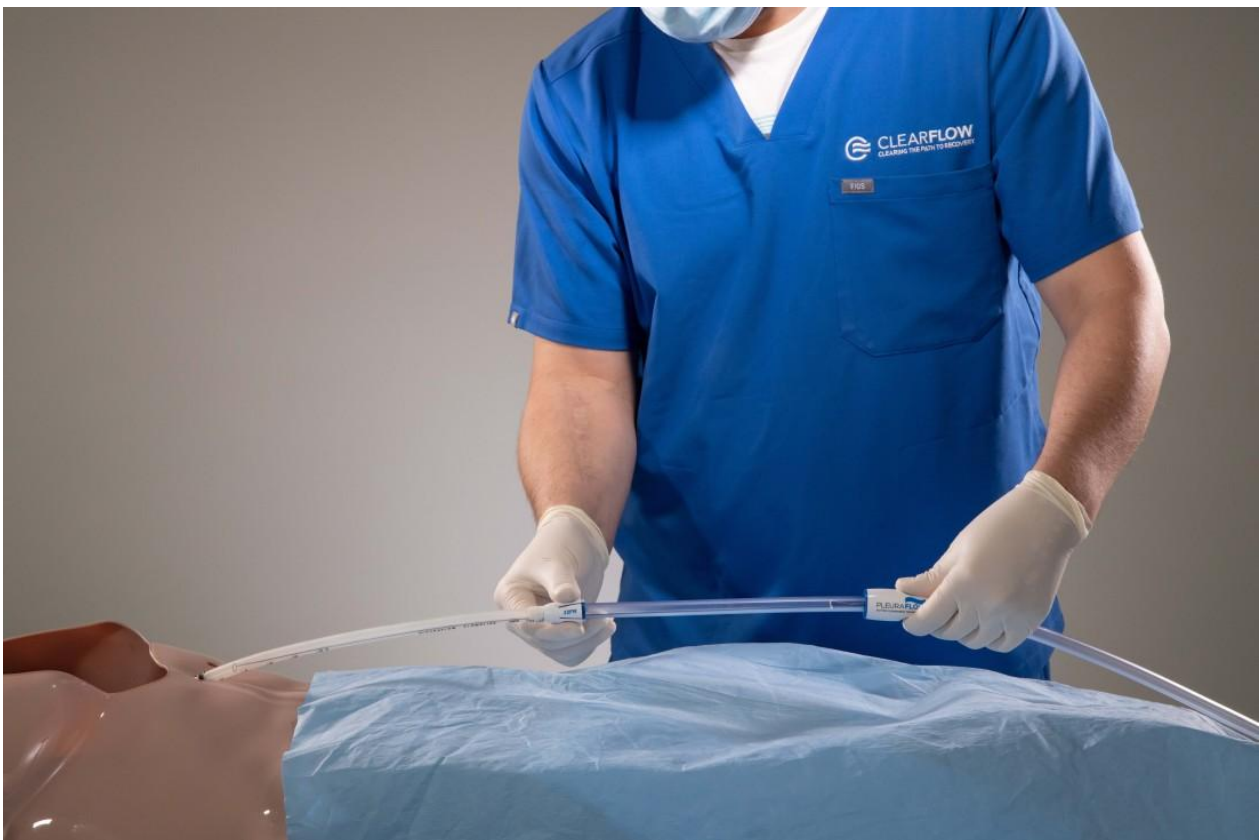
Ensure the Chest Tube and Guide Tube are as straight and parallel to the patient's body as possible when actuating. Ensure the proximal end of the guide tube is not elevated when attempting to actuate.
