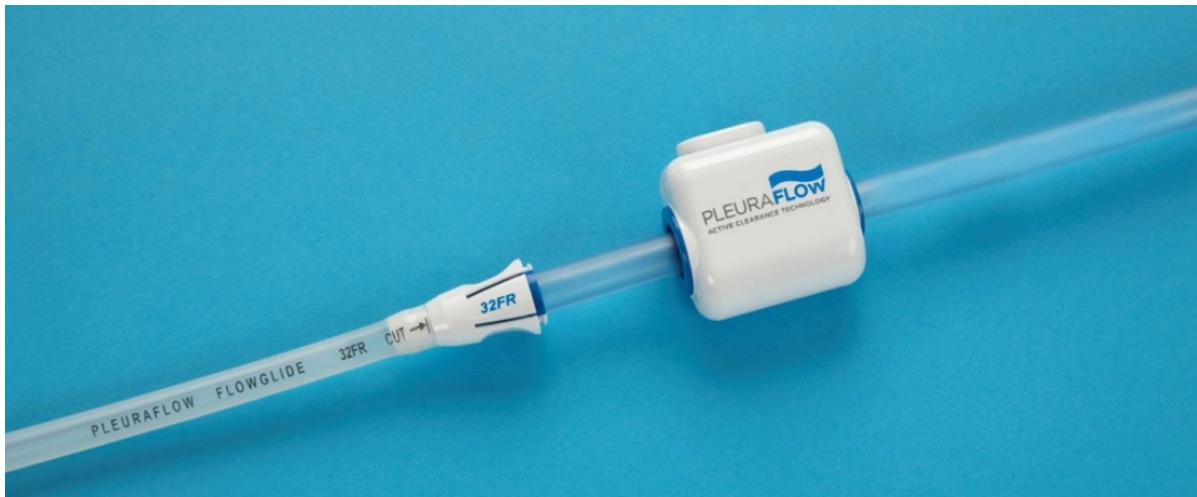
If decoupling occurs when the Clearance Wire and Loop are in proximity to the Parked Position, the Clearance Wire and Loop can continue to be used even if the Shuttle Guide does not fully click into the Parked Position.

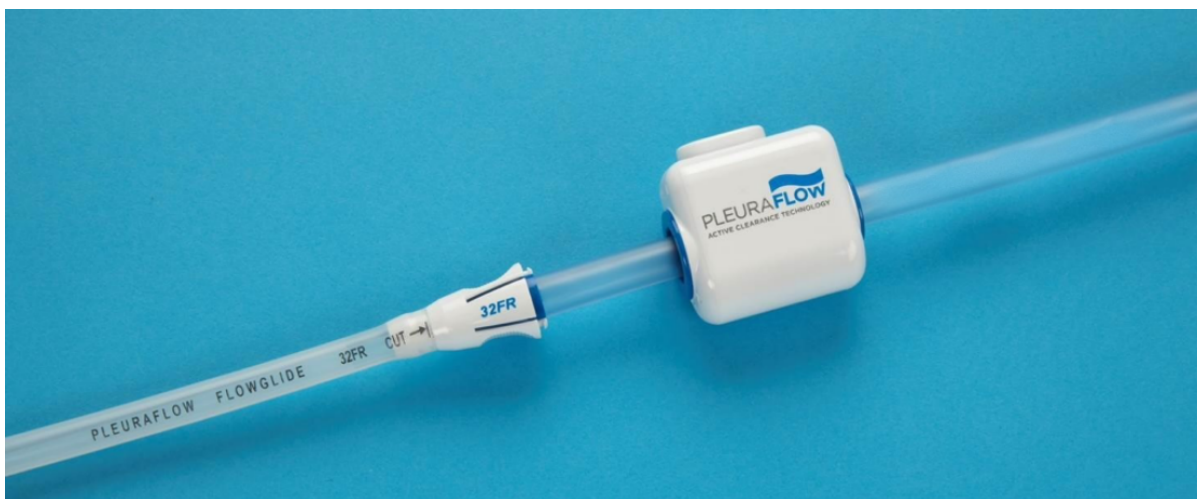
If decoupling occurs when the Clearance Wire and Loop are in proximity to the parked position, continue using the device if:

- It is not possible to click the Shuttle Guide into the proximal barb housing to park the Clearance Wire and Loop in the proximal end of the Chest Tube, and;
- There is no resistance to wire movement inside the chest tube distally to the point of decoupling.

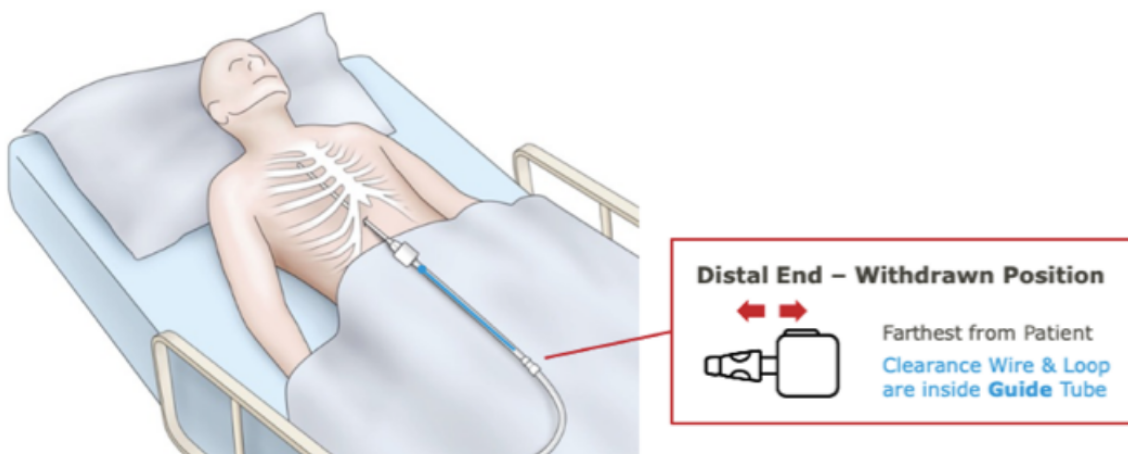
**Advancing/Parking:** If decoupling persists during advancement, slide the shuttle guide over the internal magnet to recouple and retract the clearance wire out of the chest tube, leaving it in the guide tube. Notify the ICU of the position of the Shuttle Guide and communicate the location of decoupling.
