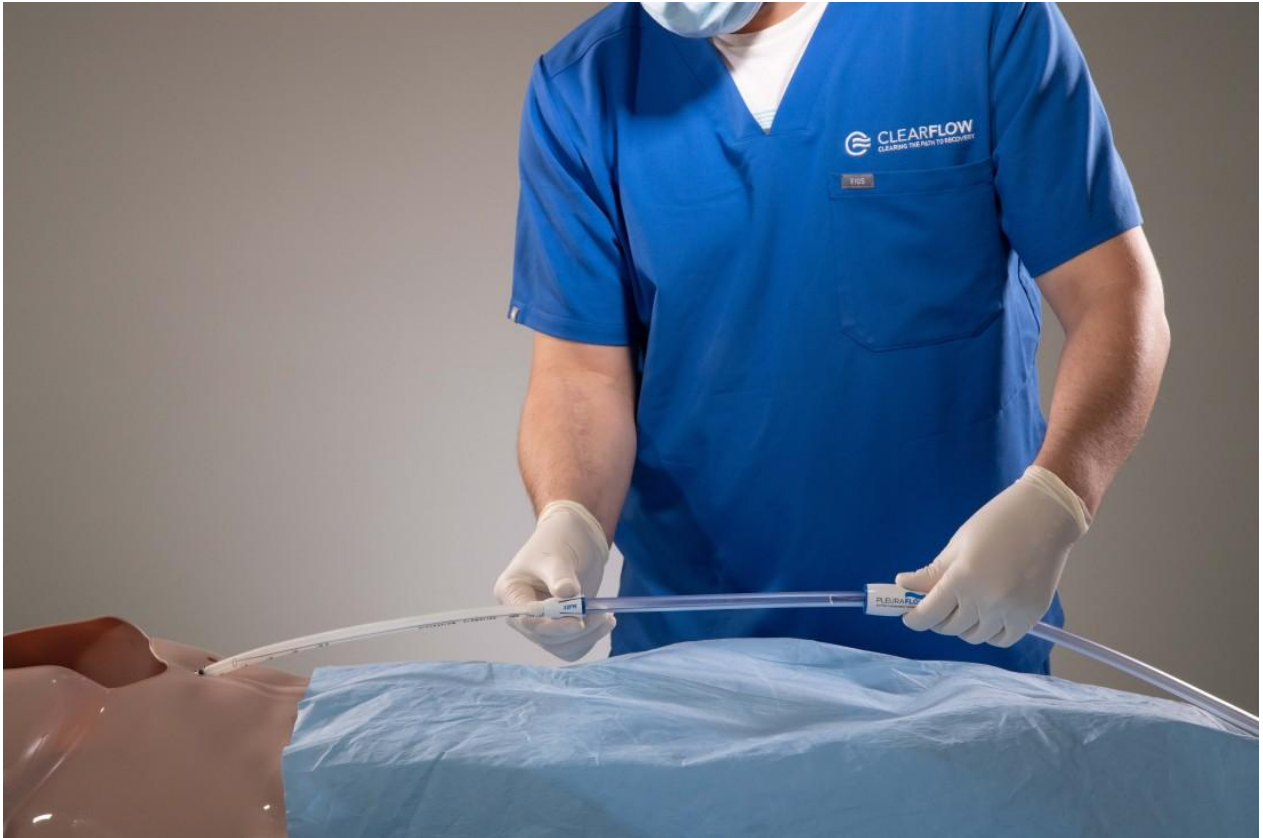
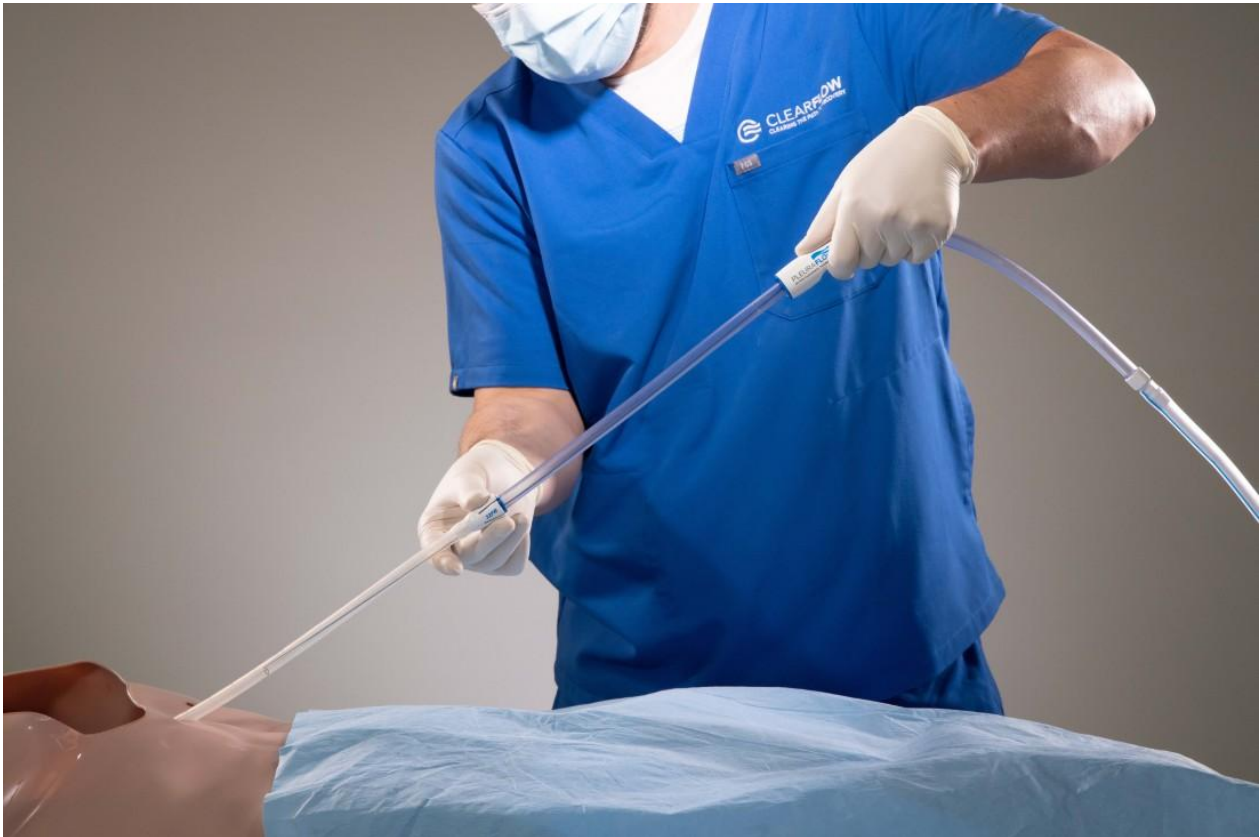
Guide Tube Path Not Straight

Ensure the Chest Tube and Guide Tube are as straight and parallel to the patient's body as possible when actuating. Ensure the proximal end of the guide tube is not elevated when attempting to actuate.

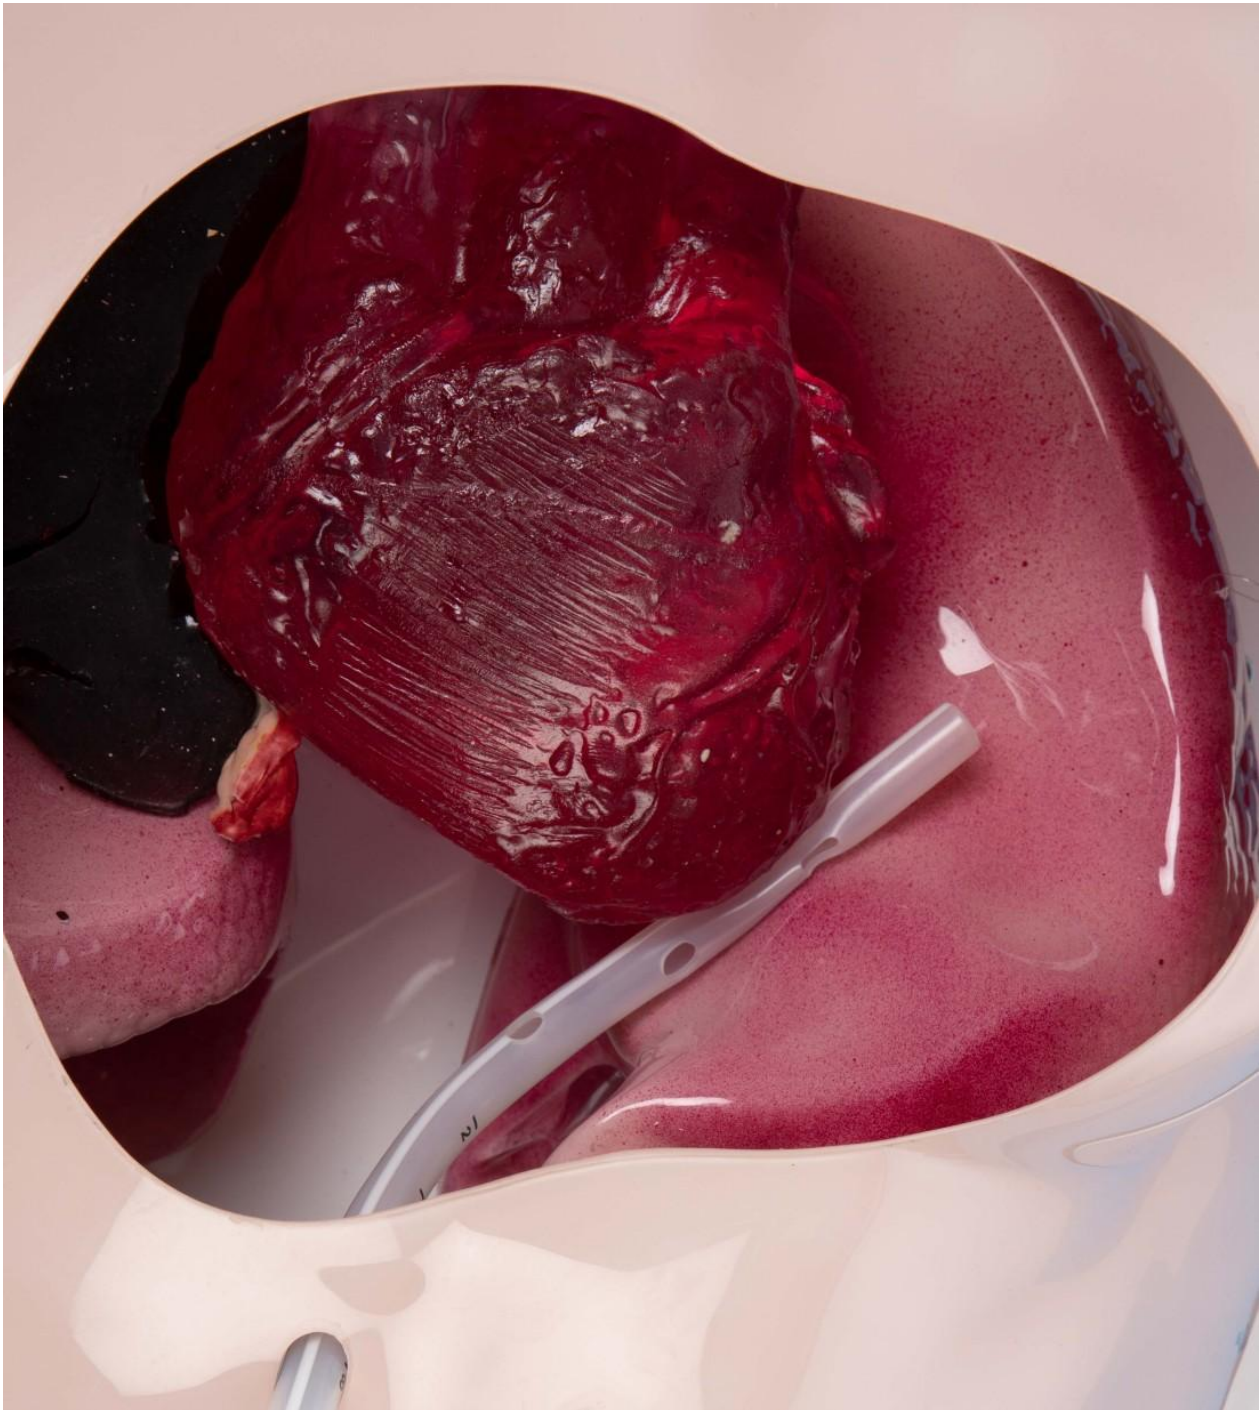
Consider Patient Positioning

The Chest Tube may be compressed by swelling inside the chest cavity or encountering resistance due to patient positioning. Reattempt actuation when the patient has been repositioned (supine to semi-fowlers, semi-fowlers to supine, sitting to supine/semi-fowlers).

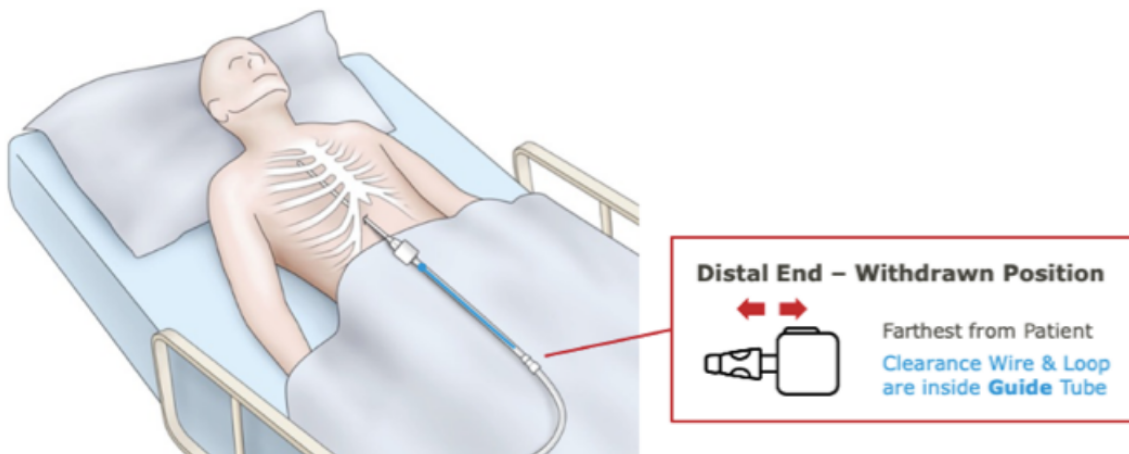
Tips

If the internal and external magnets become uncoupled, advance or retract the Shuttle Guide over the internal magnet to recouple. Retaining elements set on the internal magnets will keep the internal magnets and wire from exiting the Guide Tube, thus encouraging recoupling of the magnets.

Withdrawing/Retraction: If decoupling persists during retraction, slide the shuttle guide over the internal magnet to recouple and return to the parked position. Communicate the location of decoupling to the ICU.

Advancing/Parking: If decoupling persists during advancement, slide the shuttle guide over the internal magnet to recouple and retract the clearance wire out of the chest tube, leaving it in the guide tube. Notify the ICU of the position of the Shuttle Guide and communicate the location of decoupling.
