Guide Tube Path Not Straight

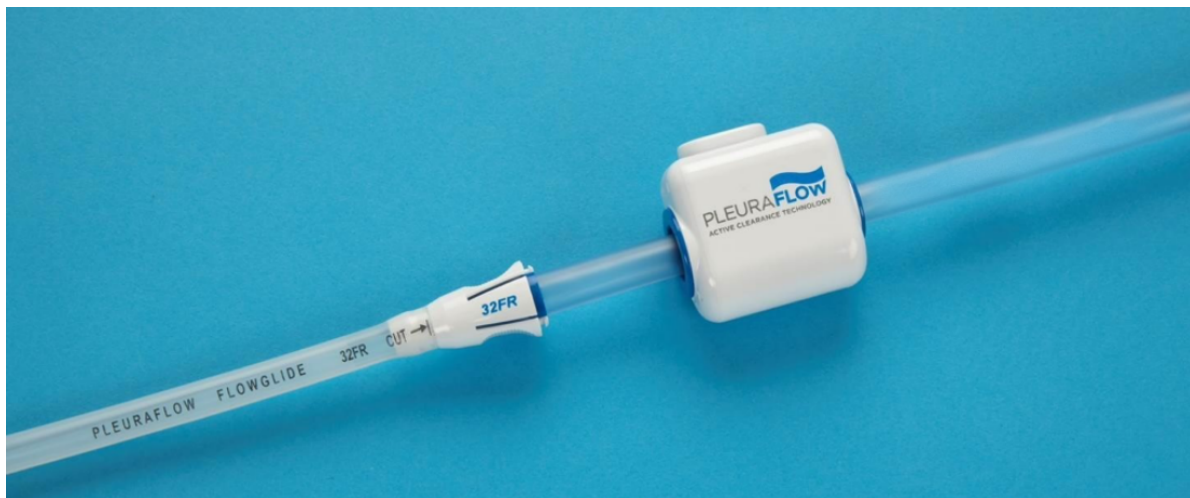
If decoupling occurs when the shuttle guide is in proximity of the parked position, the shuttle guide can continue to be used, even if not fully clicked into the parked position. Proceed with the actuation schedule.
