## Guide Tube Path Not Straight

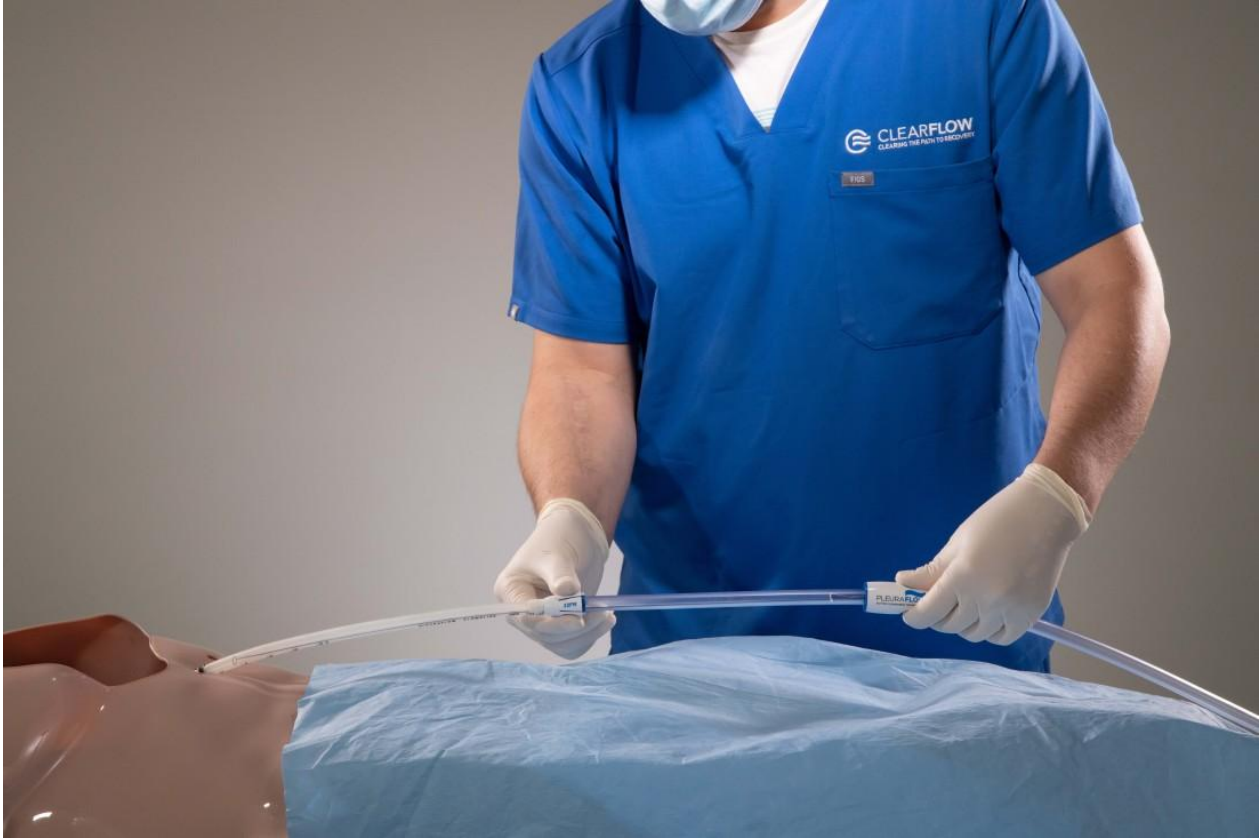
Ensure the Chest Tube and Guide Tube are as straight and parallel to the patient's body as possible when actuating. Ensure the proximal end of the guide tube is not elevated when attempting to actuate.

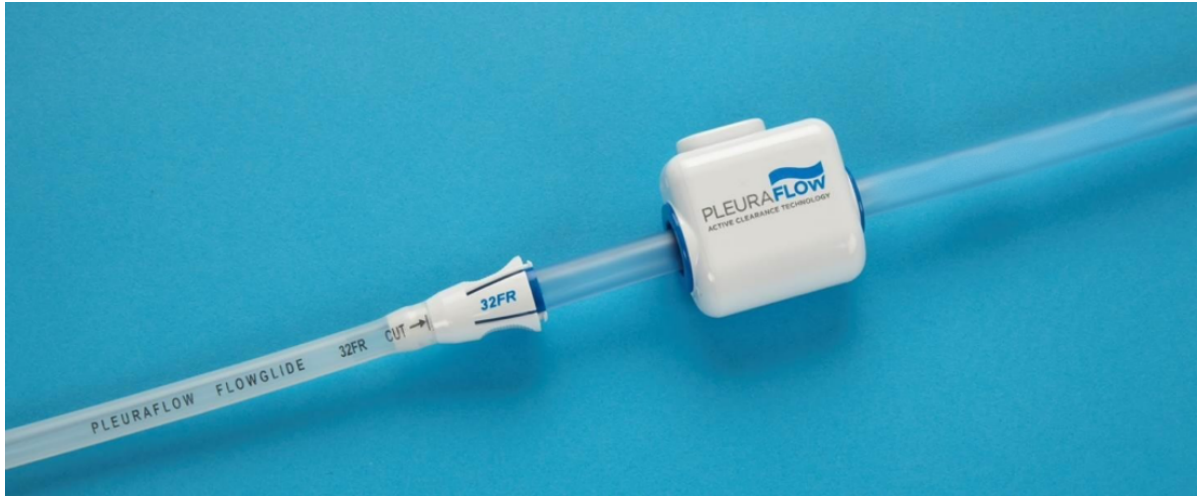
If decoupling occurs when the shuttle guide is in proximity of the parked position, the shuttle guide can continue to be used, even if not fully clicked into the parked position. Proceed with the actuation schedule.
