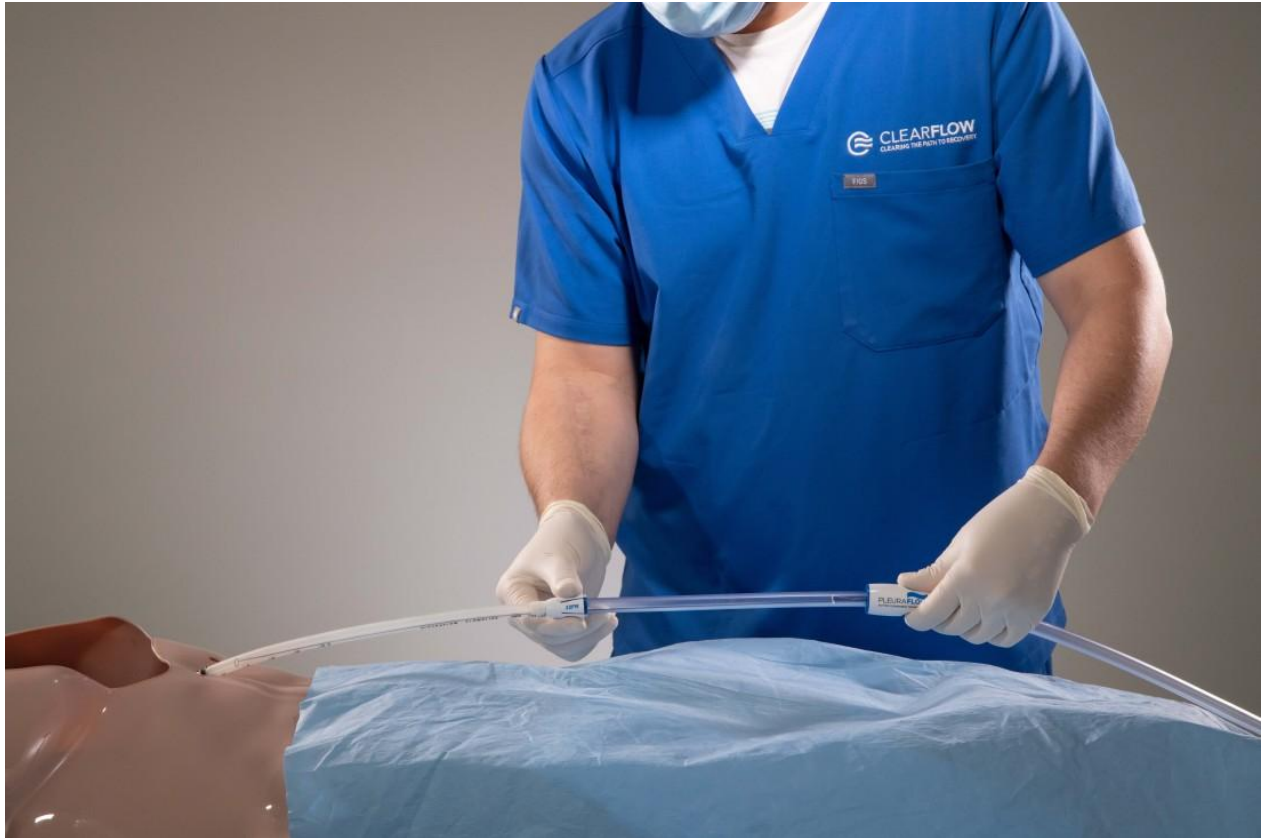
Guide Tube Path Not Straight

Ensure the Chest Tube and Guide Tube are as straight and parallel to the patient's body as possible when actuating. Ensure the proximal end of the guide tube is not elevated when attempting to actuate.
