PLEURAFLOW SYSTEM IN USE

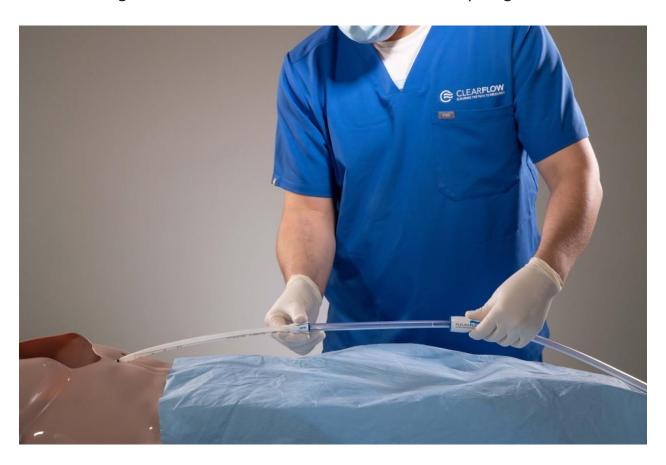
Guide Tube Path Not Straight

Ensure the Chest Tube and Guide Tube are as straight and parallel to the patient's body as possible when actuating. Ensure the proximal end of the guide tube is not elevated when attempting to actuate.
