Chest Tube/Guide Tube Junction Not Flush

Guide Tube Path Not Straight

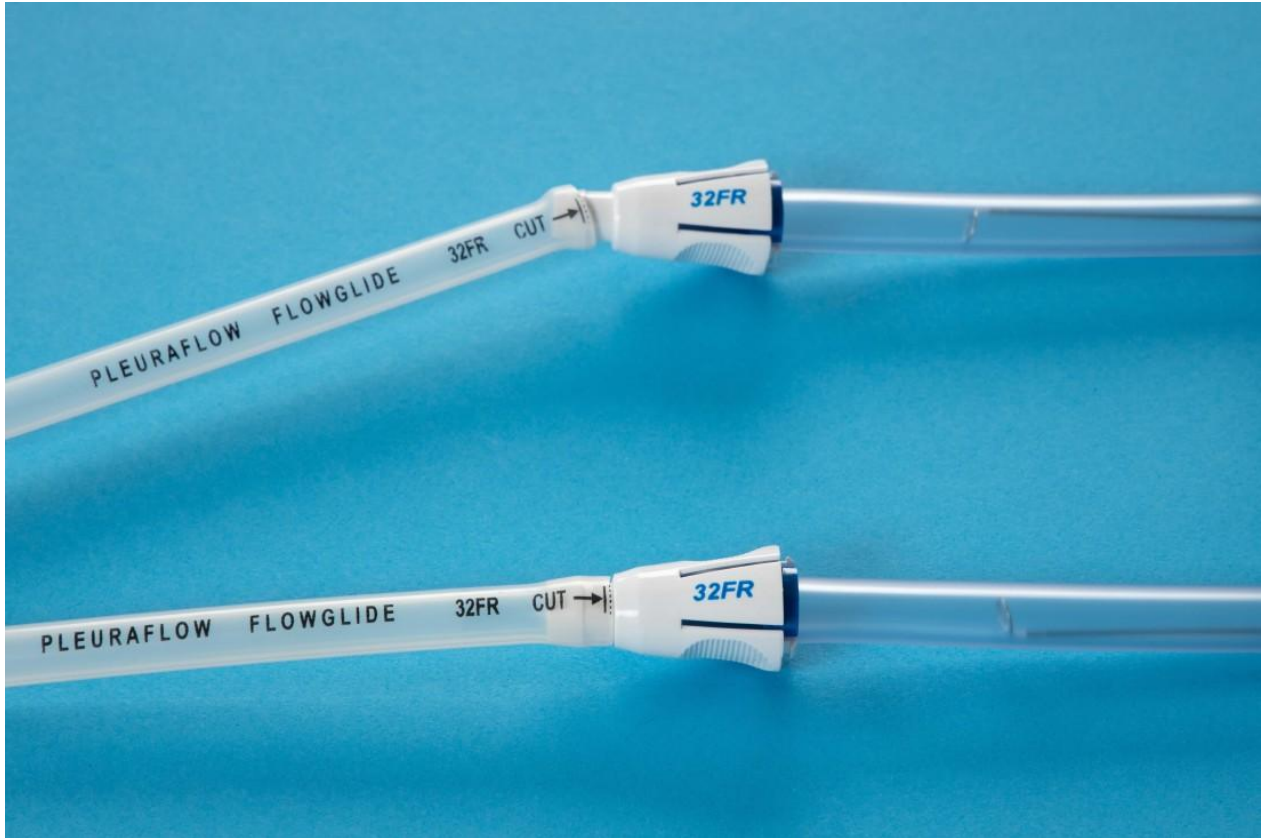
Ensure the chest tube/guide tube junction is flush and straight. If the chest tube was not cut straight on the "Cut" Line, try to straighten the cut and reattach the chest tube/guide tube junction.

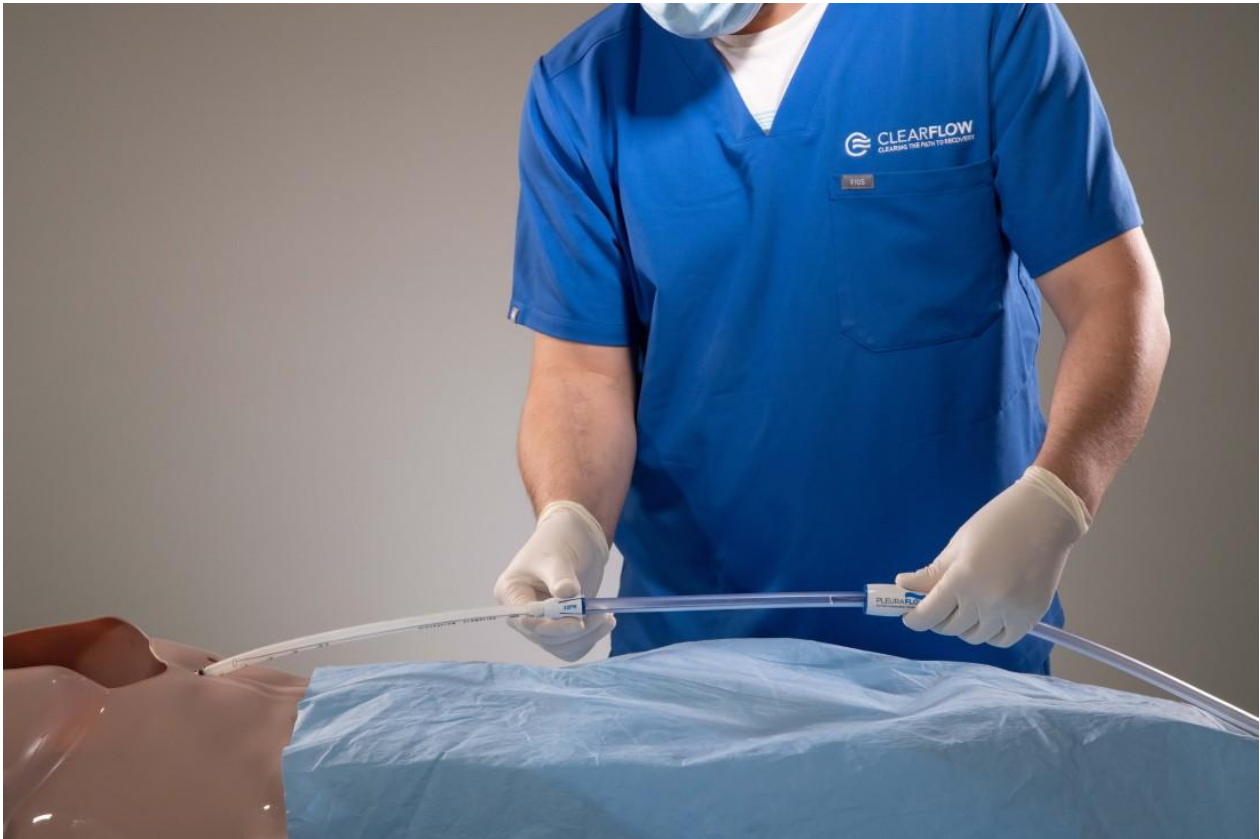
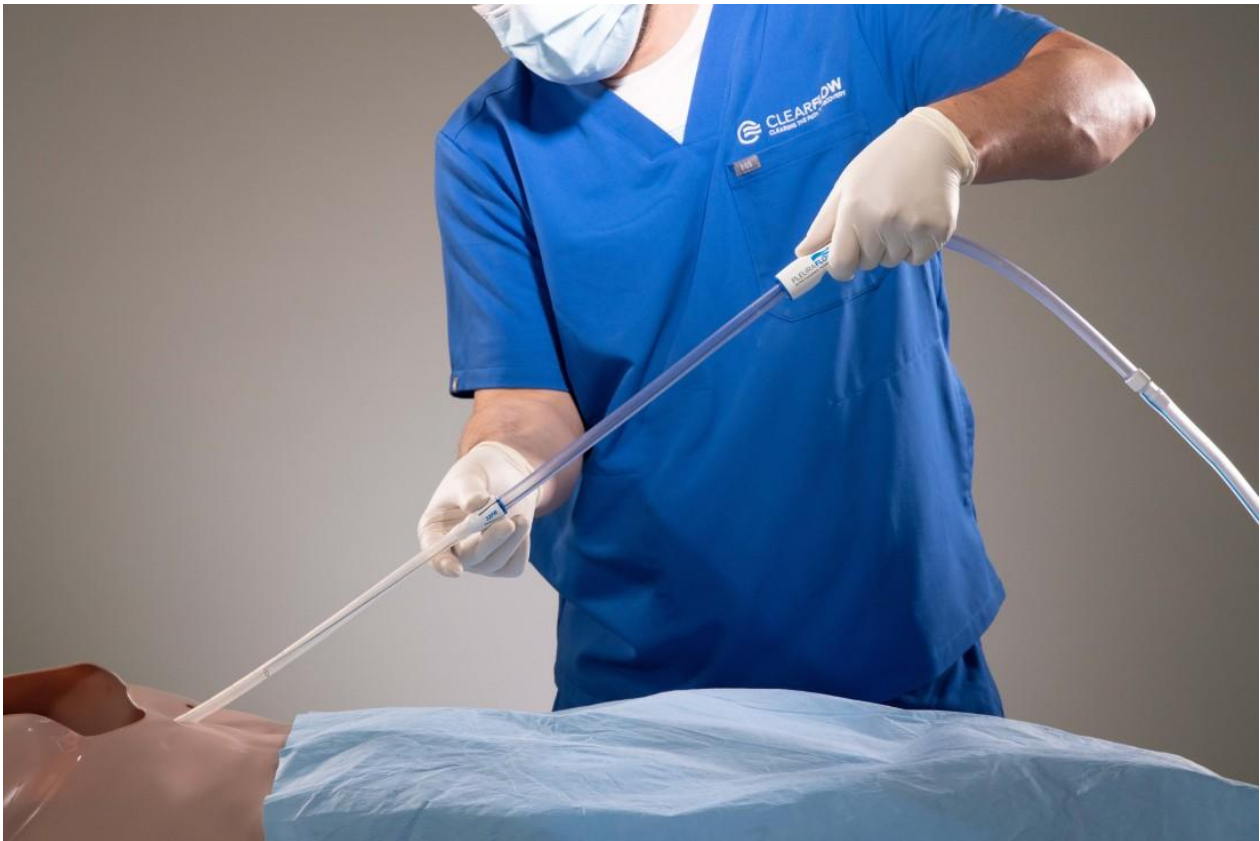
Ensure the Chest Tube and Guide Tube are as straight and parallel to the patient's body as possible when actuating. Ensure the proximal end of the guide tube is not elevated when attempting to actuate.

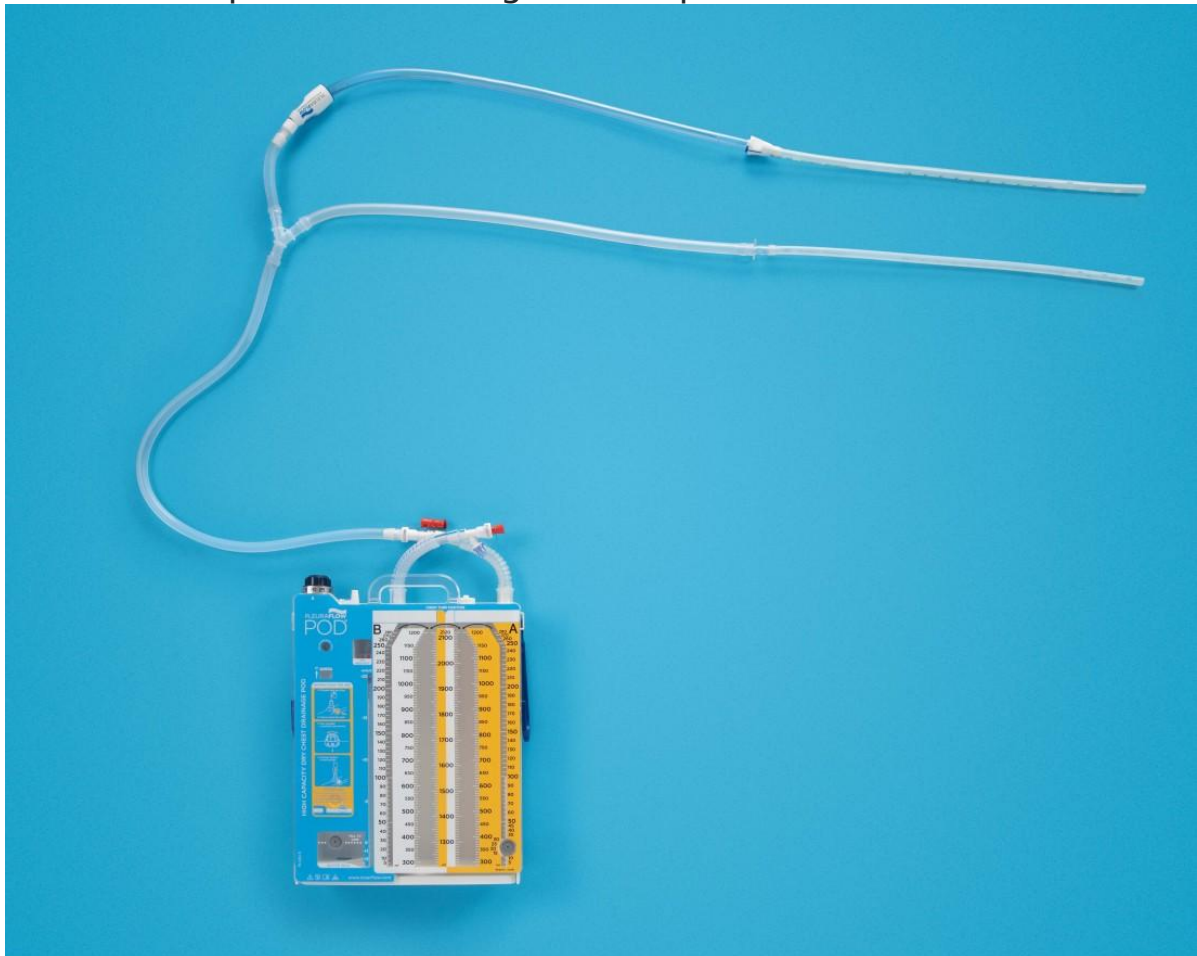
If a "Y" connection is utilized, additional drainage tubing may be used to compensate for length discrepancies.

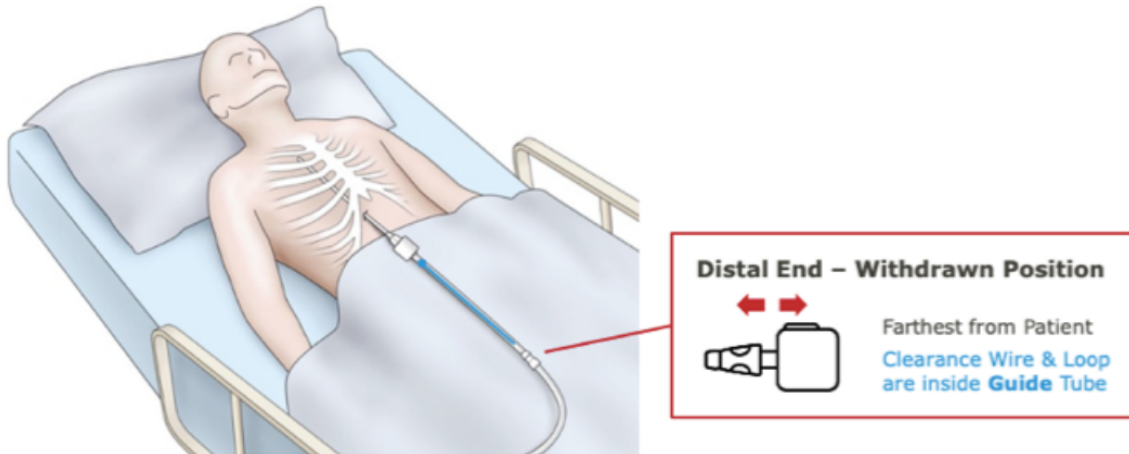
Advancing/Parking: If decoupling persists during advancement, slide the shuttle guide over the internal magnet to recouple and

retract the clearance wire out of the chest tube, leaving it in the guide tube. Notify the ICU of the position of the Shuttle Guide and communicate the location of decoupling.
