Chest Tube/Guide Tube Junction Not Flush

Guide Tube Path Not Straight

Tips

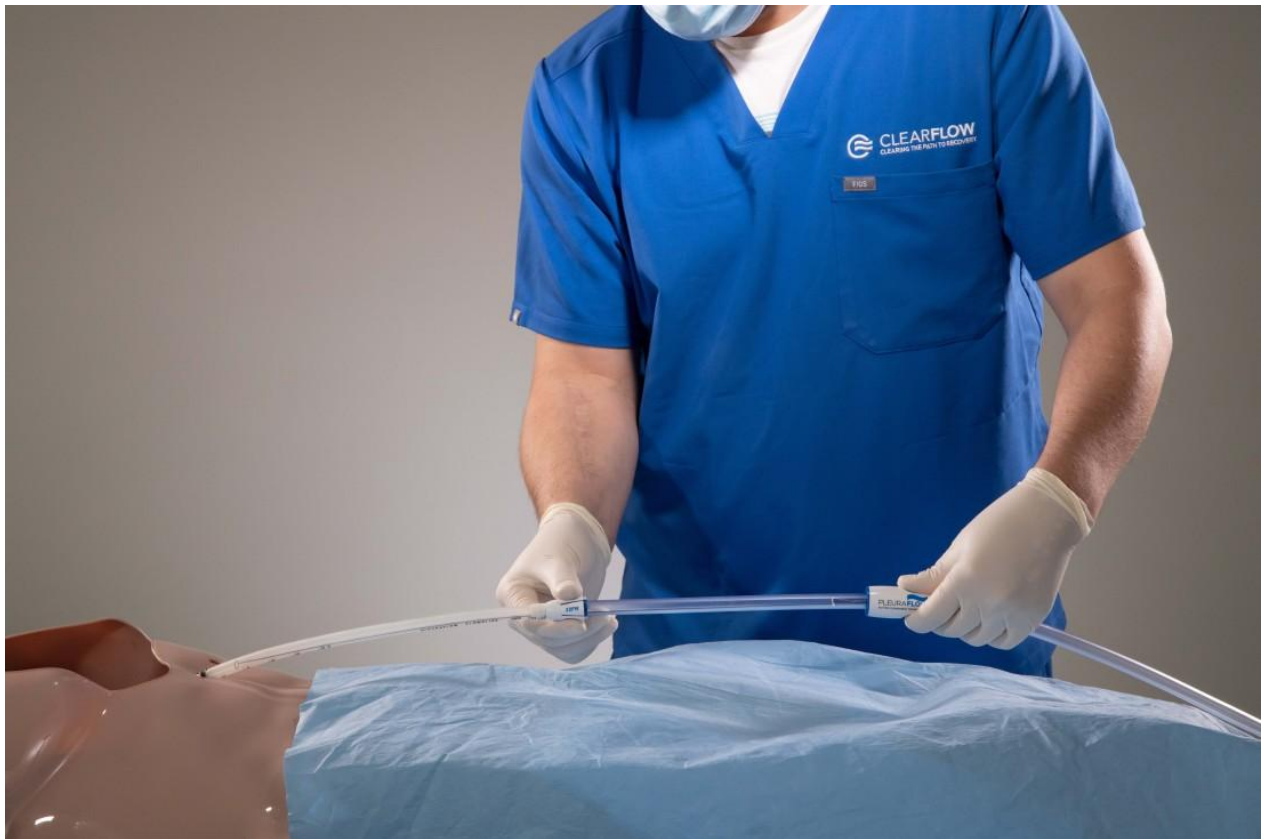
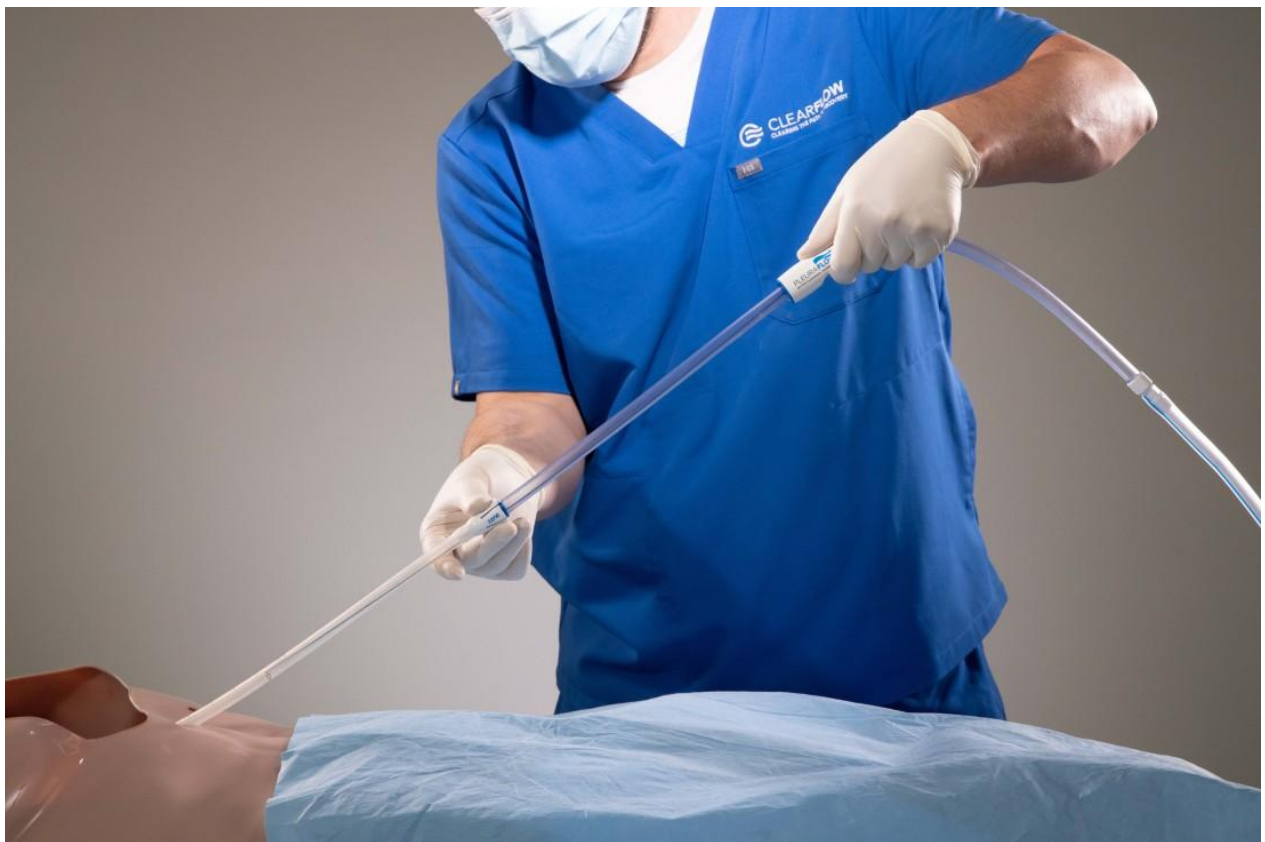
Ensure the Chest Tube and Guide Tube are as straight and parallel to the patient's body as possible when actuating. Ensure the proximal end of the guide tube is not elevated when attempting to actuate.

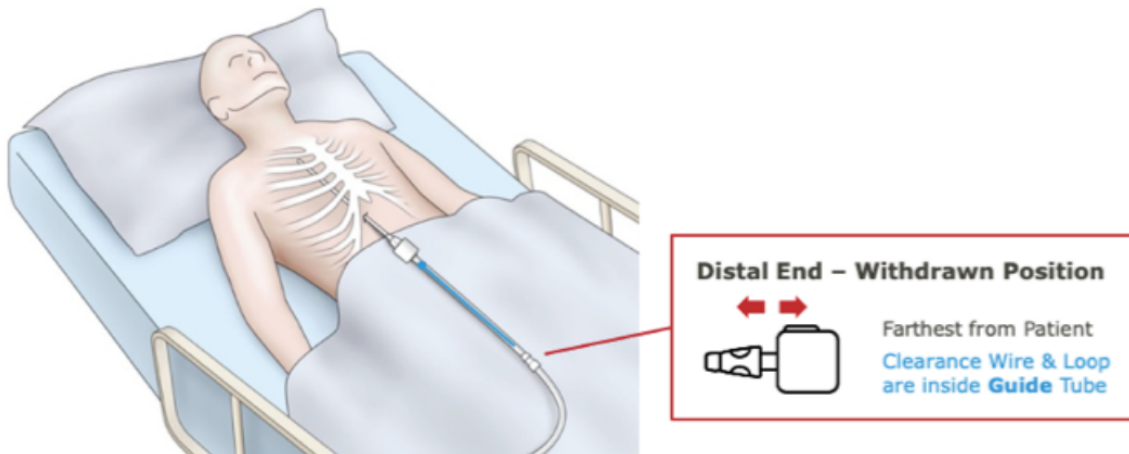
Advancing/Parking: If decoupling persists during advancement, slide the shuttle guide over the internal magnet to recouple and

retract the clearance wire out of the chest tube, leaving it in the guide tube. Notify the ICU of the position of the Shuttle Guide and communicate the location of decoupling.
