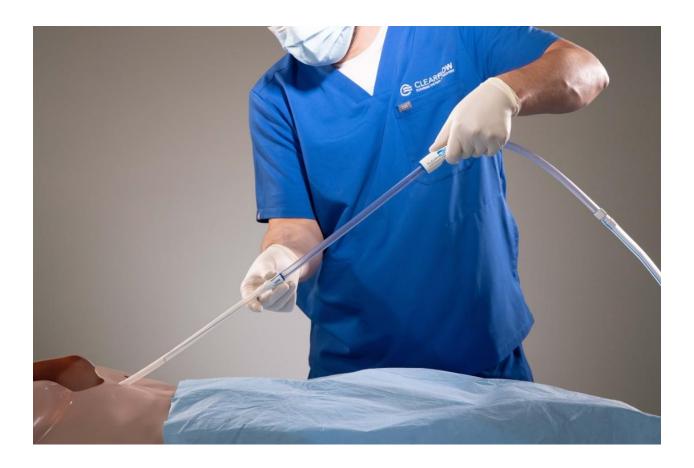
## Guide Tube Path Not Straight

Ensure the Chest Tube and Guide Tube are as straight and parallel to the patient's body as possible when actuating. Ensure the proximal end of the guide tube is not elevated when attempting to actuate.

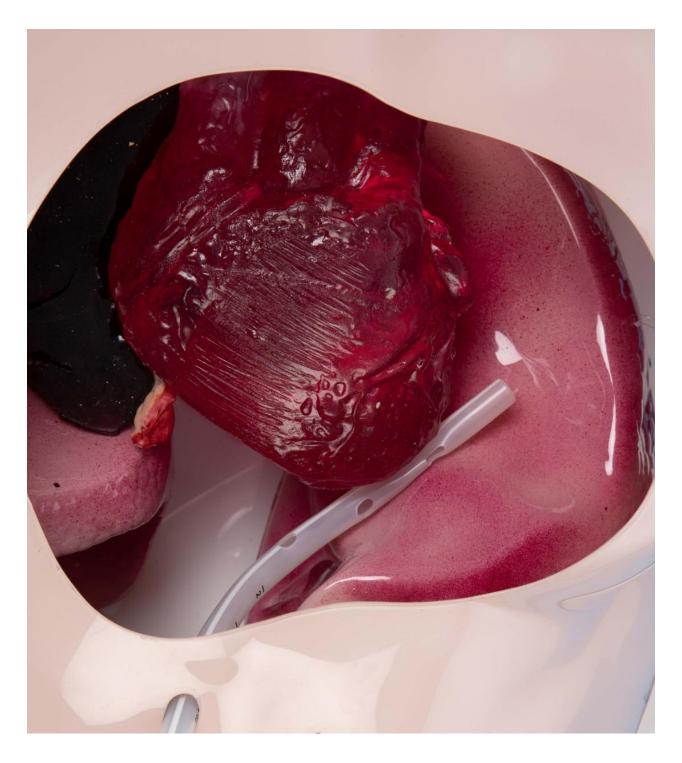
## **Consider Patient Positioning**

The Chest Tube may be compressed by swelling inside the chest cavity or encountering resistance due to patient positioning. Reattempt actuation when the patient has been repositioned (supine to semi-fowlers, semi-fowlers to supine, sitting to supine/semi-fowlers).
